THE
ONTARIO WATER RESOURCES
COMMISSION

INVESTIGATIONS OF FOG CONDITIONS

COPPER CLIFF AREA

JUNE, 1968

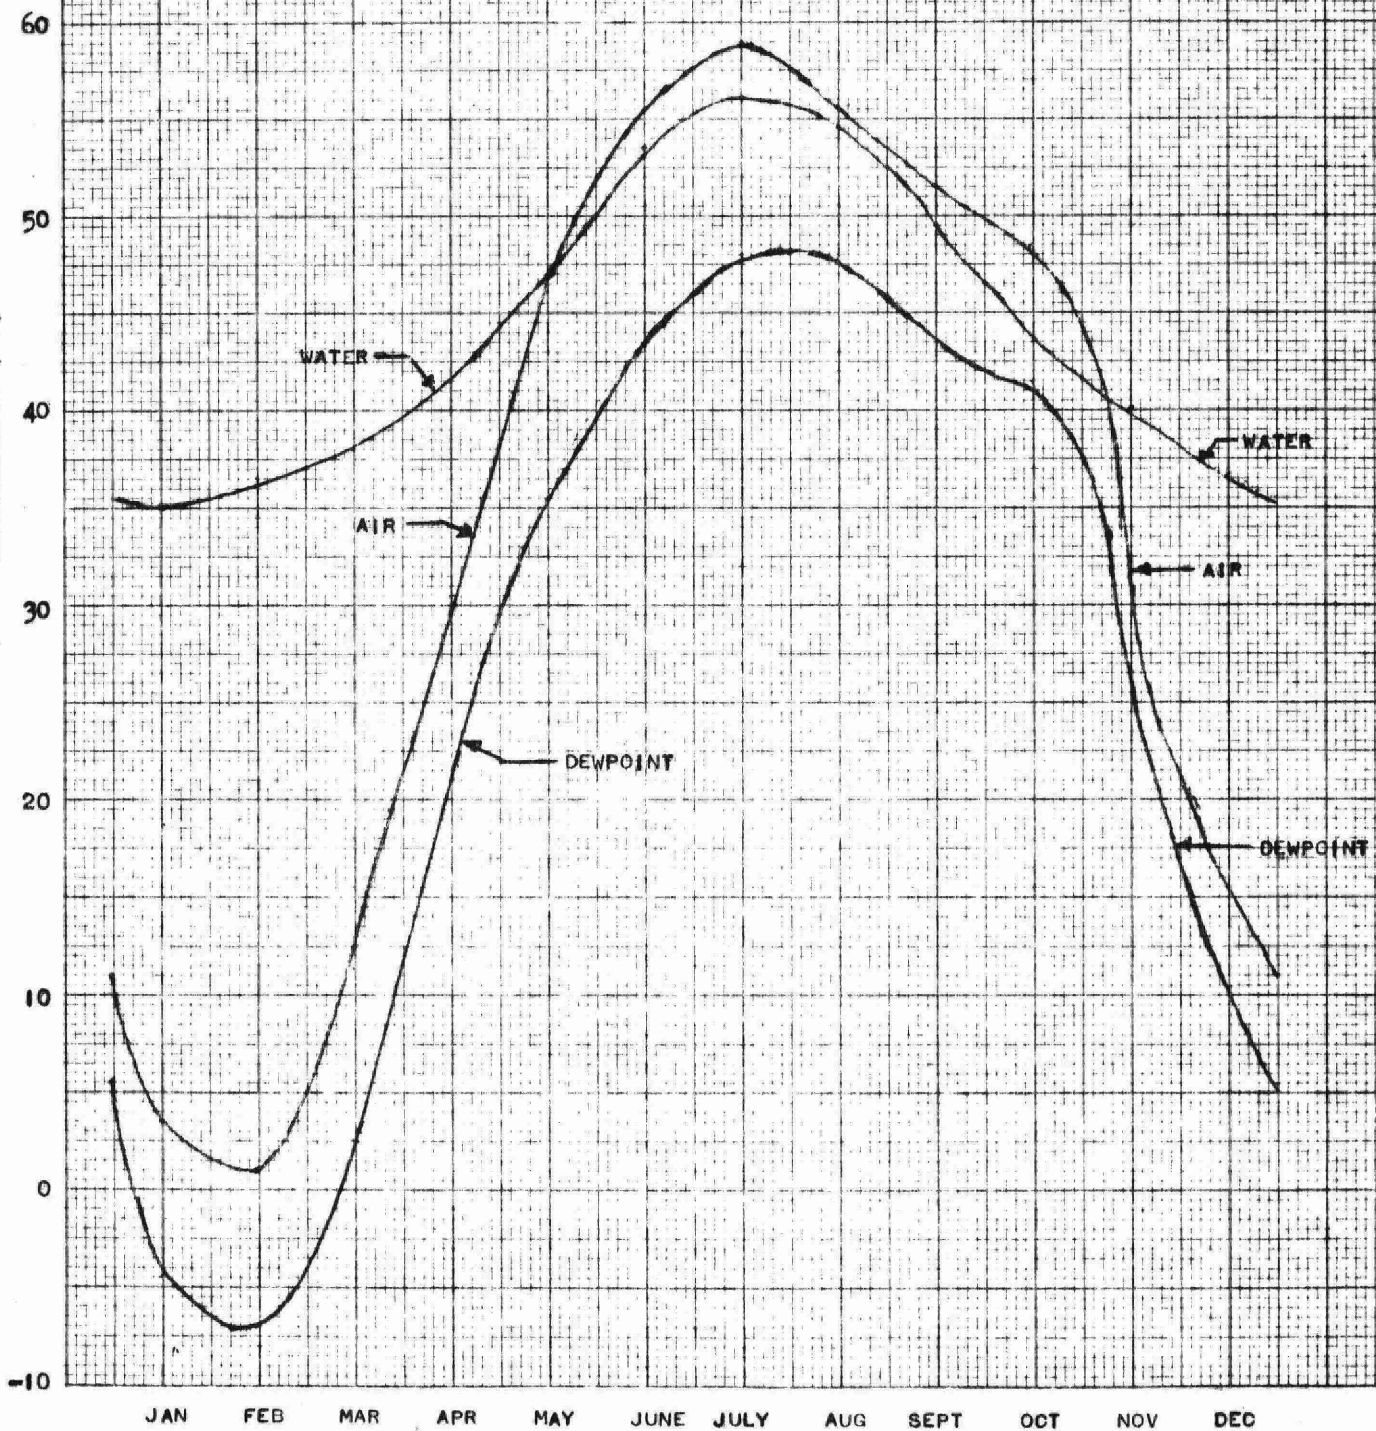
FIGURE 2

A graph of air temperature, approximate creek temperature and dew point for a one-year period was also presented and is reproduced in this report as Figure 2. According to the report, localized fog conditions were limited to the approximate period from November to May since the dew point and the air temperature were closest during this period, giving maximum probability of the dew point being equal to the air temperature.

Air, dewpoint and
creek temperatures.

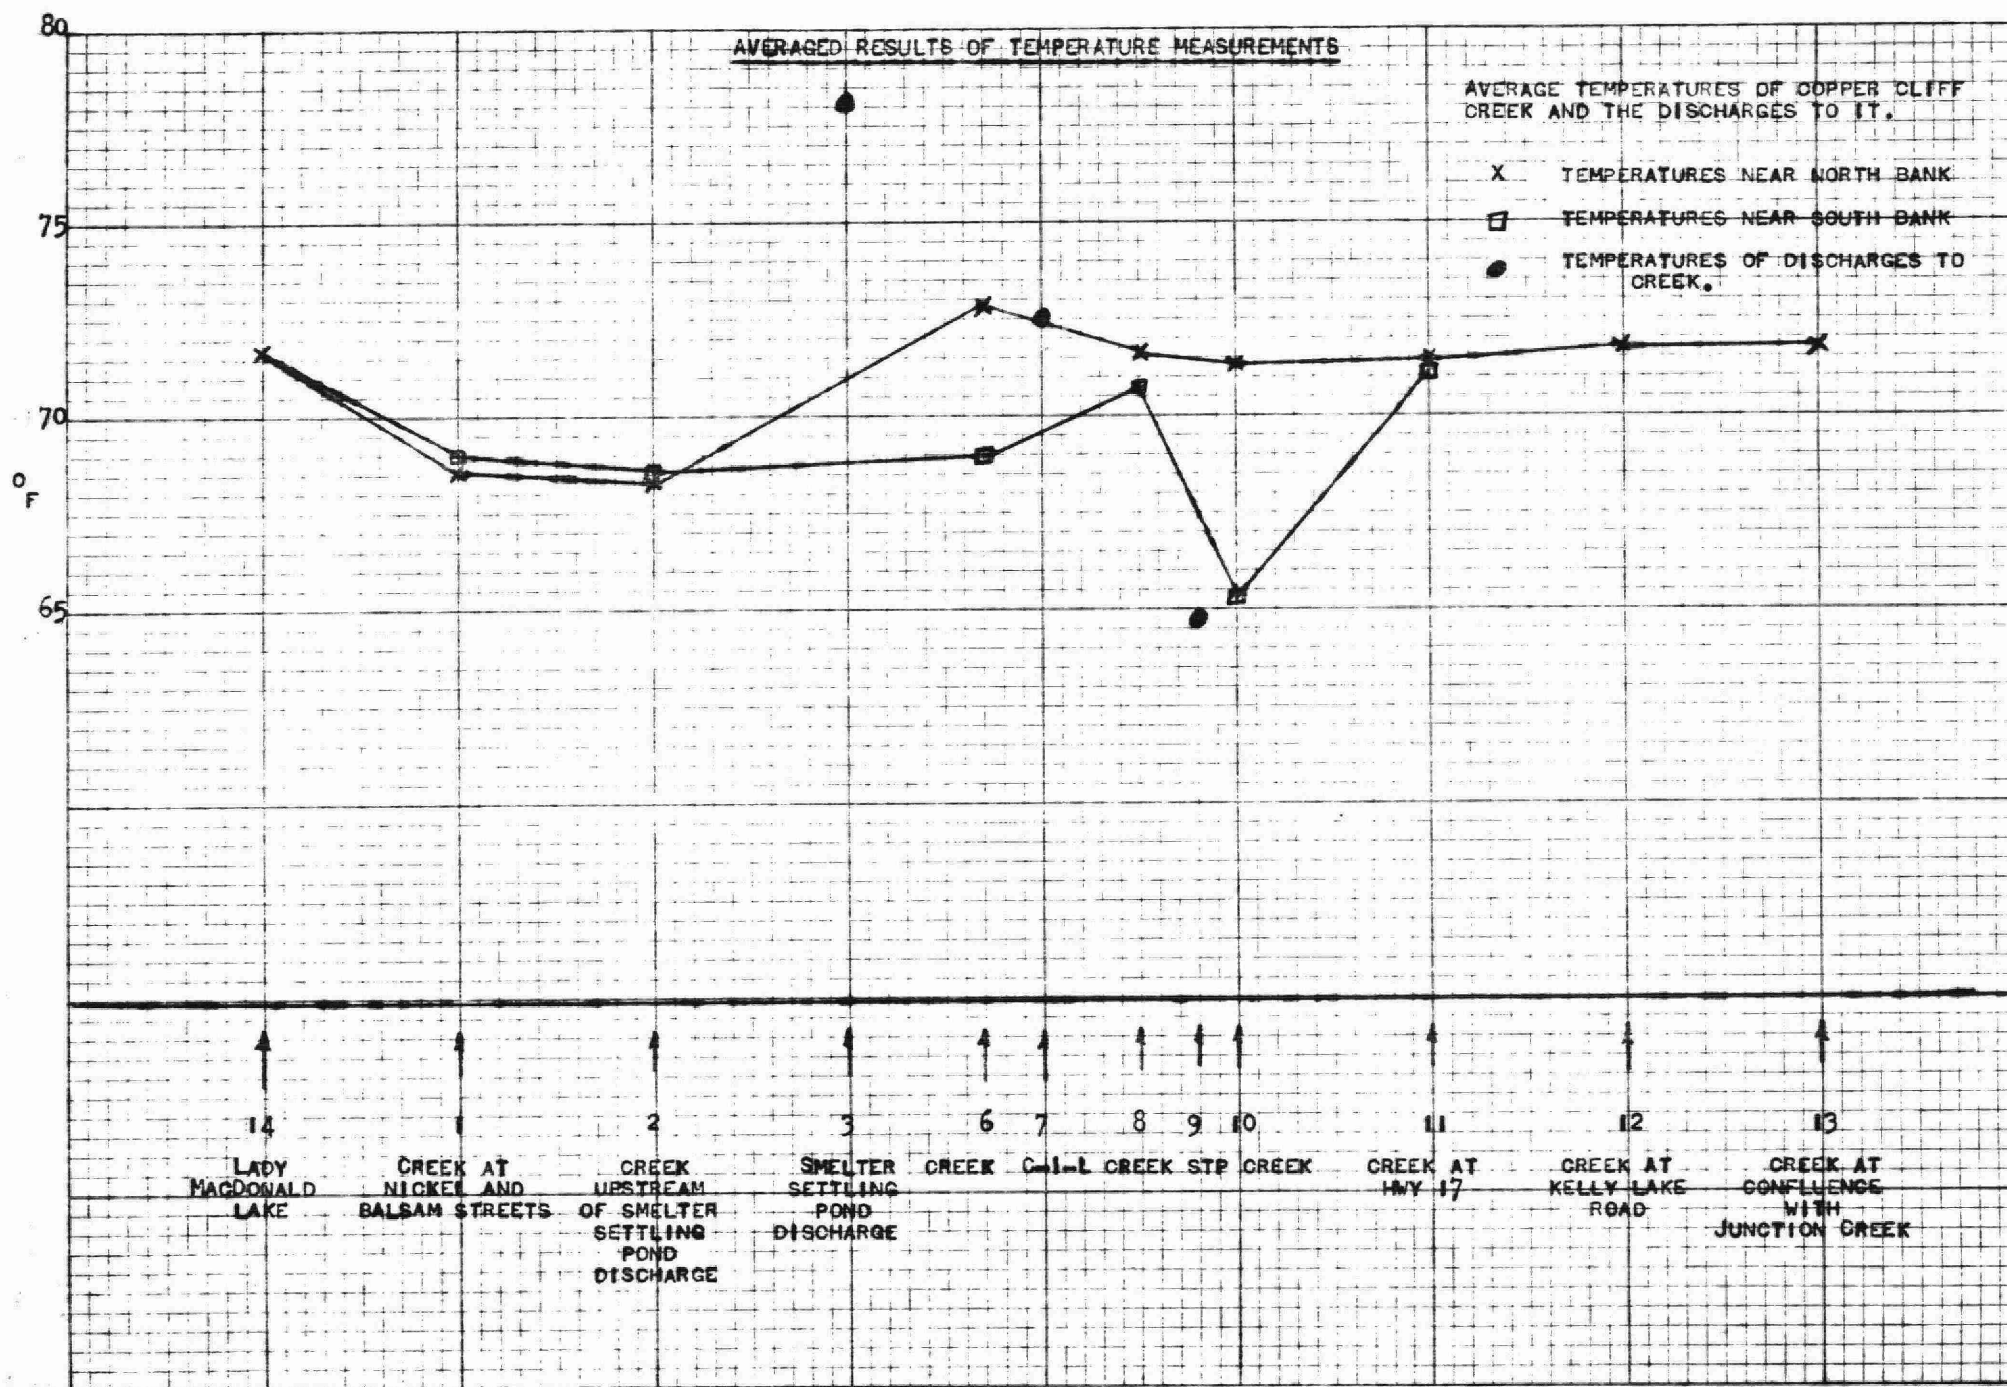
FIGURE 3

The field results are tabulated in Table III of this report. Averaged results for sampling periods 2-6 are presented graphically in Figure 3. Sampling periods 1, 7 and 8 were not included in the average because at those times, temperature readings were not obtained at all the points. The resulting plot presents an average temperature profile of the creek for June 3 and 4, 1968.

Referring to Figure 3 and the tabulated temperature data in Table III, a marked temperature gradient across the creek was observed from the point of entry of the smelter waste discharge downstream to the railway overpass. Further downstream, at the point where the creek crossed the highway, thermal mixing had apparently been achieved since the temperatures near the two banks were identical or approximately identical.

The average temperature of the creek upstream of the smelter waste effluent discharge was 68.5°F. The average smelter effluent temperature was 76.8°F. Downstream of the smelter, the temperature of the creek had risen to 72.8°F on the north side of the creek. A very small temperature rise of about 0.5°F was observed on the south side.
